Type of Incident

Hand Injury

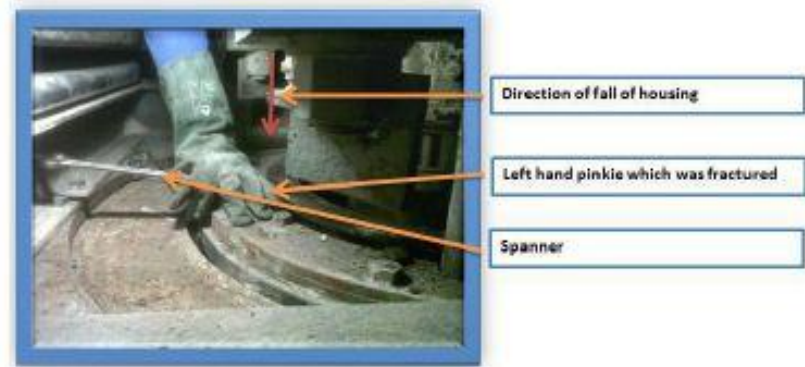
A crew was working in a bearing compartment, removing retaining bolts securing the housing cover. Difficulty was experienced during this process and a supervisor asked an associate, who was carrying out a different task at that time, to assist them. The associate was instructed to hold a spanner in place while the other workers in the team loosened the bolts from the underside of the housing cover. As the last retaining bolt was removed, the housing cover dropped injuring the associate's finger.

- Restricted working space
- Injured associate was not expecting the housing cover to drop
- Poor communication between the parties involved in the task
- No supports in place to control the housing cover's movement when released from its retaining bolt

- Risk Assessment and Safe Work Procedure to be reviewed and amended as required
- Pre-task briefing to all persons involved in this type of work to be carried out
- Identify and implement measures to improve communications between associates involved in similar tasks
- Install supports to prevent the housing cover from dropping after being released from its retaining bolts
