Type of Incident

Hand Injury

Summary of Incident

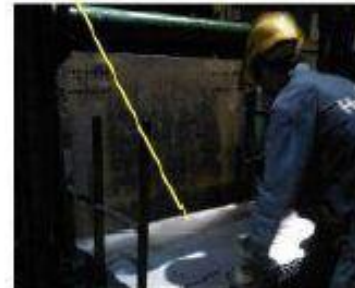
An associate was working on the element line, moving and packaging cut elements from the guillotine to the element box. During this task, the associate noticed a pair of elements cut by the guillotine sitting in the wrong position. While trying to adjust them, a second pair of elements dropped from the transfer belt striking and cutting the associate's right index finger.

- The procedure for this operation states that where any intervention is required by associates, the element line must be stopped before any intervention can be taken
- The hand protection being worn by the associate did not offer the right level of protection against cutting hazards

Cut elements

- Reinforce the importance of associates following the correct procedure for this task
- Conduct a review of the risk assessment and task procedure. An action plan should be developed for any identified areas of improvements
- Conduct a review of the adequacy of PPE for the task. Review should include consulting with associates, taking onboard any feedback to identify suitable hand protection
