Location Country: Italy

Type of incident: falling down from elevated work

Summary:

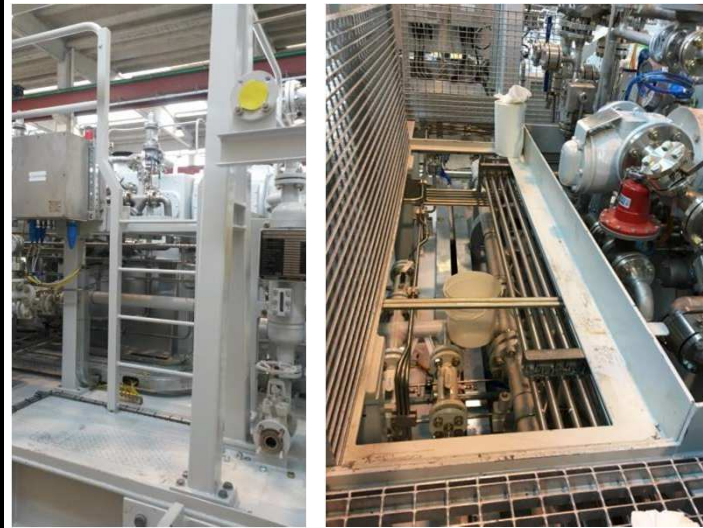
During manual painting on a horizontal reciprocating compressor, a contractor Operator did not observe that the gangway has been temporarily removed; He fell down for about half a meter, bumping with the chest on compressor pipe.

- ✓ The Person which has completed painting, or others, did not cover the grating which has been removed (contractors coordination ineffective);
- ✓ absence of safety sign that highlighted the temporary situation of danger.

- ✓ Ensure regular contractors meeting, in order to reduce interferential risks;
- ✓ use dedicated safety sign that highlights the temporary situation of danger.
