Type of Incident

Unsafe load

Summary of Incident

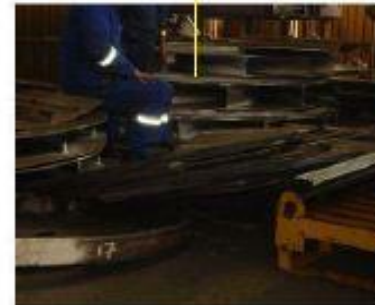
- Failure to maintain a safe working environment for associates in this area
- Blade skins were being stacked too high, due to lack of storage space
- Blade skins were not secured to the pallet
- Workshop layout was poor

Congested working area

- Conduct a review of the workplace layout and develop an action plan to improve the safety of associates in this area. Review should consider appropriate storage locations for blade skins, and opportunities to improve pedestrian and vehicular interaction
- Consider available options to secure blade skins to pallet while being transported and stored
- Conduct safety awareness training for all people in this area, reminding them of the importance of being aware of their surroundings

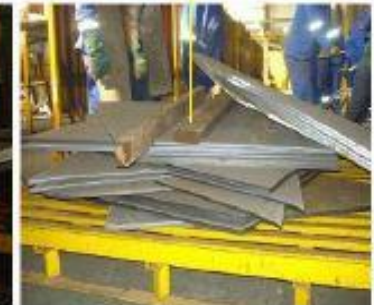
An associate was waiting for the arrival of a blade skin which he was going to mark out with chalk. While waiting for the blade skin delivery, a forklift driver was busy delivering a second set of blade skins, positioning them onto a different stack. While being loaded, one of the blade skins slid from the stack, striking and fracturing the foot of the associate who was standing nearby.

Stack of blade skins after incident
