Italy

Type of incident : ignition & fire

ICAAMC
International Compressed Air
& Allied Machinery Committee

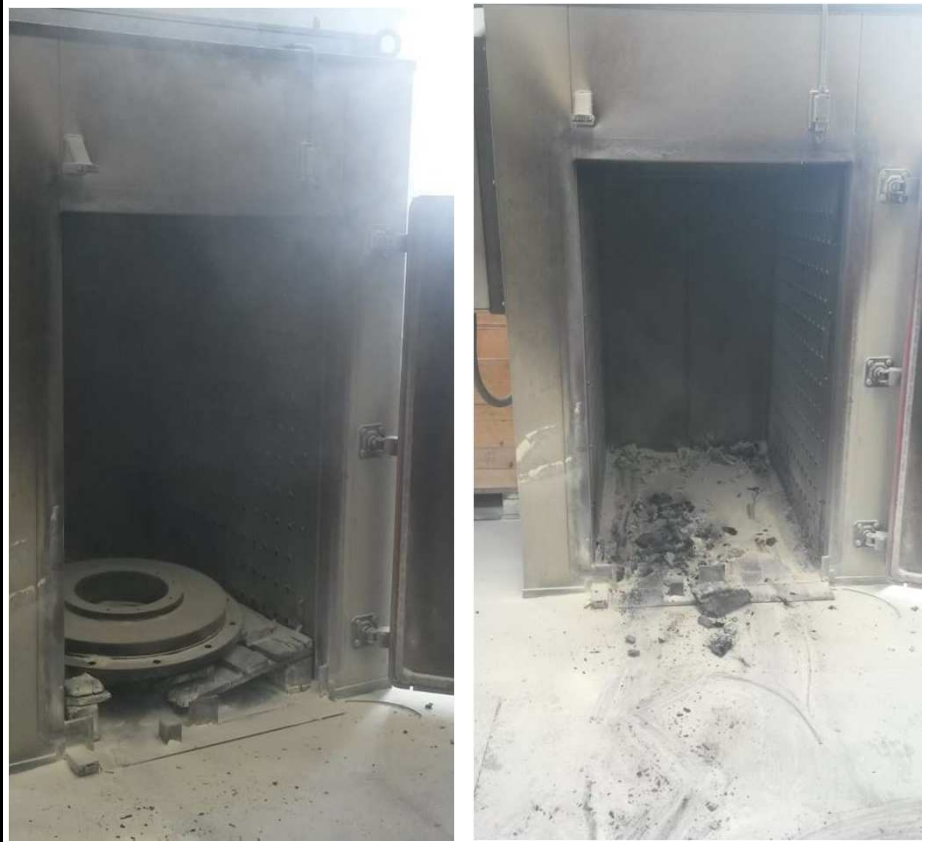
The episode happened during heating of a cover for the mechanical assembly of bearings on crankshaft of a vertical reciprocating compressor; such a cover has been by mistake located onto a wooden pallet inside the oven for three hours at a temperature of 180°C: an operator discovered that an external temperature monitor was indicating 300°C, thus signalling presence of internal fire. At that moment, He saw smoke escaping from the electric oven; erroneously He opened a little the door of the oven: flames almost reached Him. The operator put out the fire with two portable fire extinguishers; the wooden pallet which was inside, has been caught by fire.

- ✓ No adequate metallic structure has been used for heating;
- ✓ lack of knowledge of combustion and fire fighting risk.

- ✓ Manufacturing of a metallic structure;

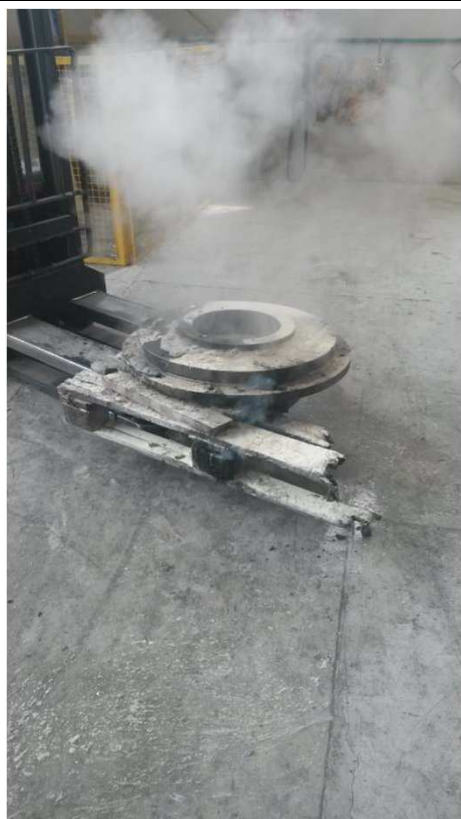
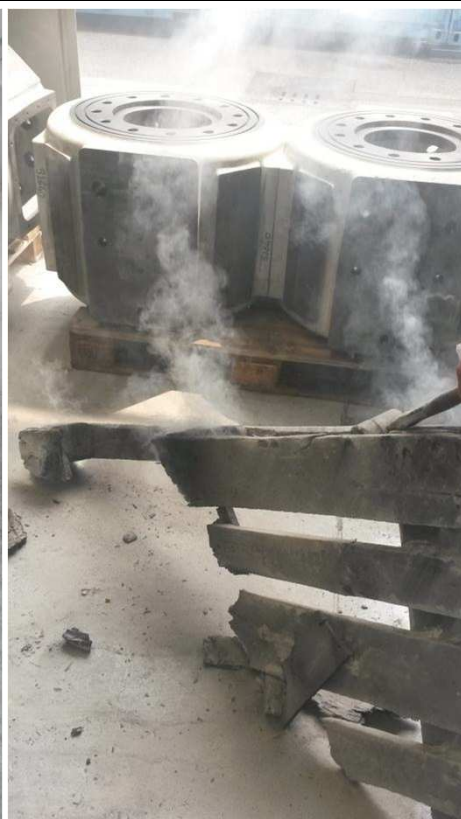
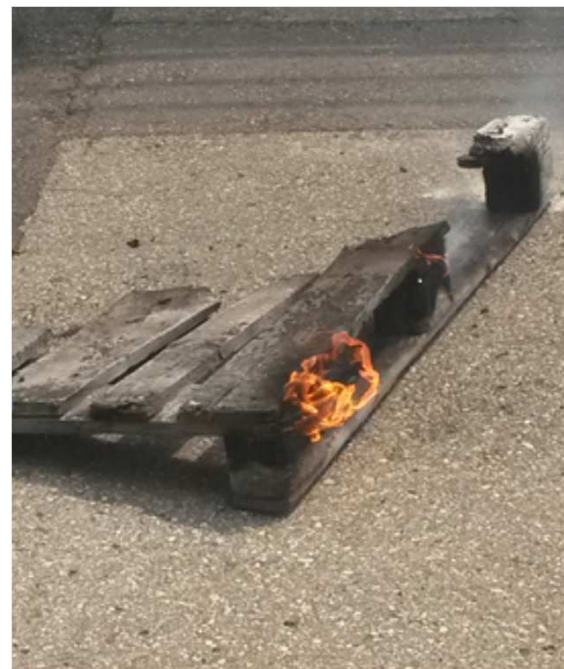
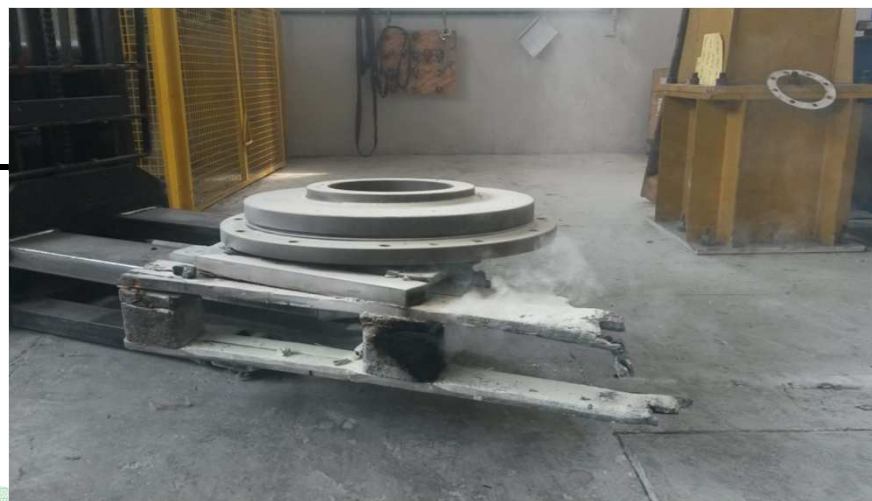
Type of incident : ignition & fire
