Type of Incident

Hand Injury

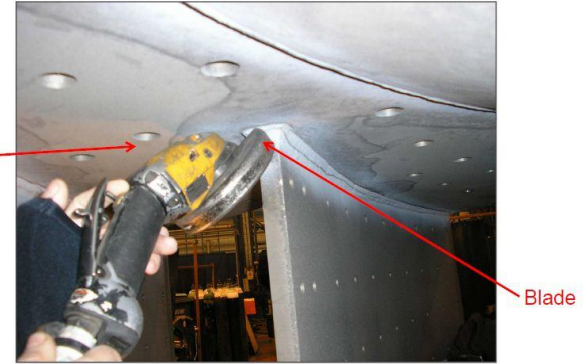
Whilst an employee was undertaking a grinding operation the grinder stalled. As the employee released pressure on the grinder, it kicked back, injuring the employees hand and fingers

Note: Photograph for illustration purposes only. Gloves are mandatory PPE for this task.

- Work being carried out in a restricted space
- Type of grinder used for the task was not ideal
- Full abrasive wheel training had not been given to the employee in this instance

- Review risk assessment for task and amend as necessary
- Review activity in accordance with risk assessment and amend as necessary
- Carry out appropriate training for all associates involved in this type of activity
- Investigate appropriate grinding equipment for this type of activity
