Location Country: Italy

Type of incident: Projection of objects

Summary:

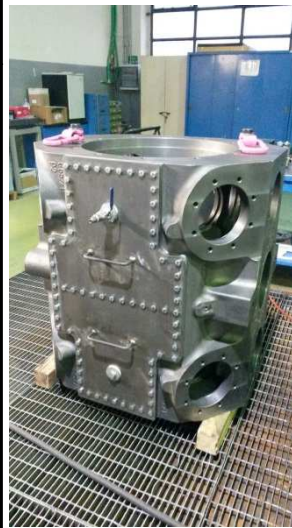
While He was drying– at the end of a hydraulic test– a compressor’s cylinder, a contractor’Operator was hit in the left eye by dust, notwithstanding He was dressing safety glasses.

This was the compressor’s cylinder in question

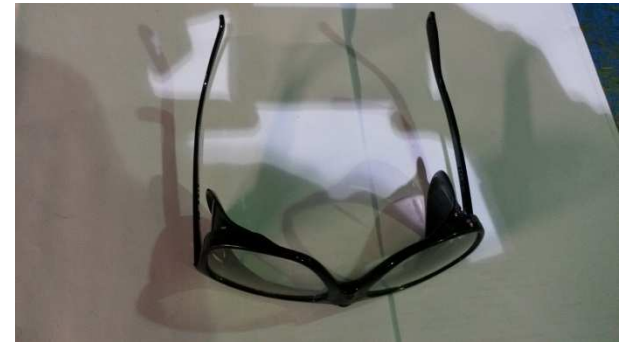
This type of glasses allow room to particles to fly

- Unsuitable PPE to protect eyes;
- repetitive type of incident;
- lack of descriptive statistics related to this contractor;
- difficulty in finding an adequate type of PPE due to the «cold wall» phenomenon

- Ask the contractor to:
- give evidence of PPE training of personnel involved in the event;
- adopt goggles to protect eyes.
